APPENDIX D

Budget Estimate

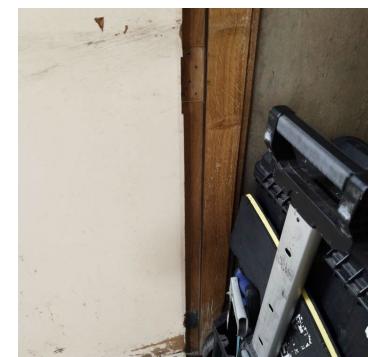
dry riser in caretakers office

Insert intumescent and smoke seals to door and install compliant 3No hinges.
(missing hinge)

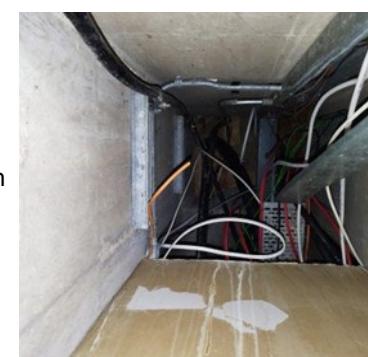
dry riser in caretakers office

Install fire blankets/batts to seal off void from soffit down to walls . Riser within open office/corridor areas

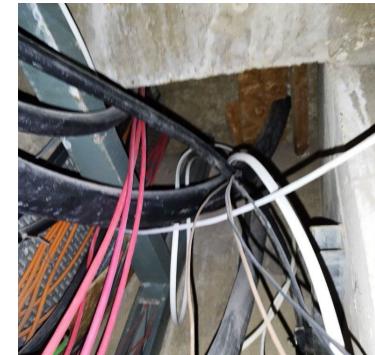
Ground floor area A dry riser in caretakers office

Where armoured cable passing through soffit, the underside is OSB board. -
check status of floor above. - Soffit and seal

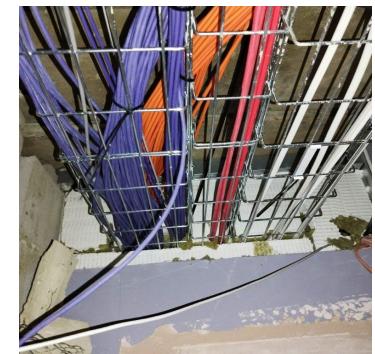
Ground floor area B The old PACE room.

Seal around cable breaches fire stopping batts with open plan office area.

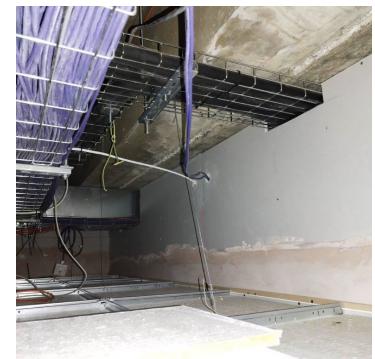
Ground floor area B The old PACE room.

Seal around cable tray and ducting passing through and into main open plan area.

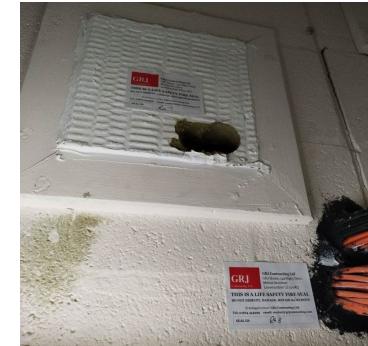
meeting room 013

Cut out and replace damaged fire stopping batt where pipework /cables have been removed. - Fire wall 30mins

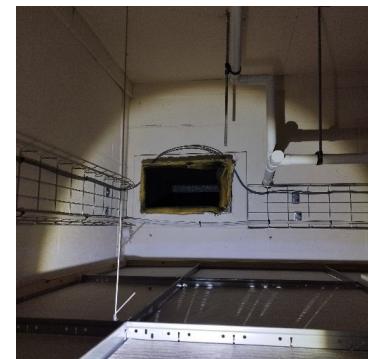
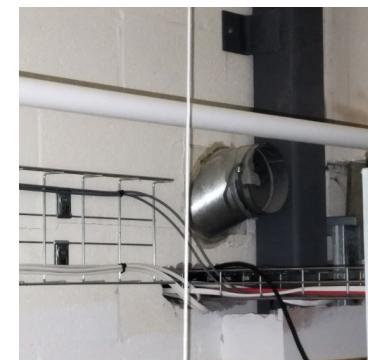
post room

Confirm if 2No ducts are redundant and if so, seal ends. Ventilation ducting stopped short at wall and not connected to ceiling grills.

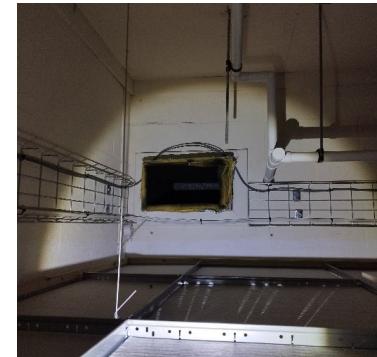
post room

Seal around waste pipe passing through wall

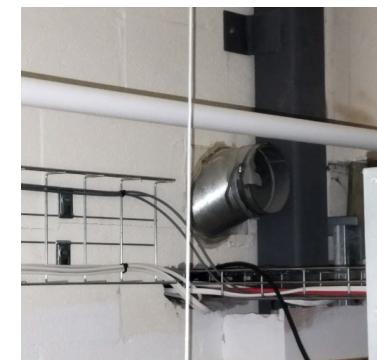
post room

Seal around cable tray passing through wall

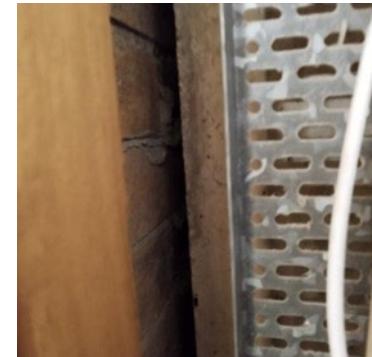
Ground floor area E
dry riser and ceiling to side corridor C0.13 off the rear entrance.

Seal gap between columns and brickwork on both sides of door frame. To full height of dry riser

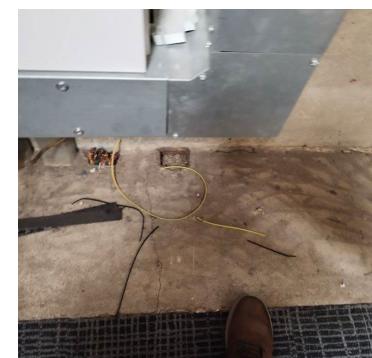
Ground floor area E
dry riser and ceiling to side corridor C0.13 off the rear entrance.

Cables passing through ground floor slab have not been properly sealed. -
Ground floor slab

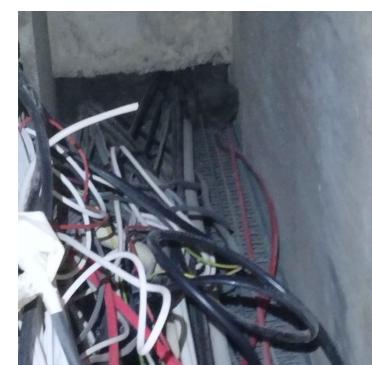
Ground floor area E
dry riser and ceiling to side corridor C0.13 off the rear entrance.

Seal cables passing through soffit on both sides of dry riser. – check status of floor above

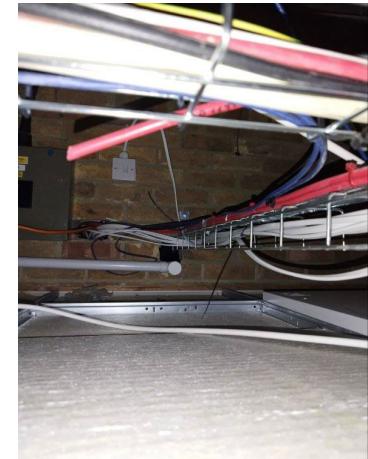
C0.13 Corridor ceiling void

Seal around plastic waste pipe, cable tray and cabling alongside old isolators.

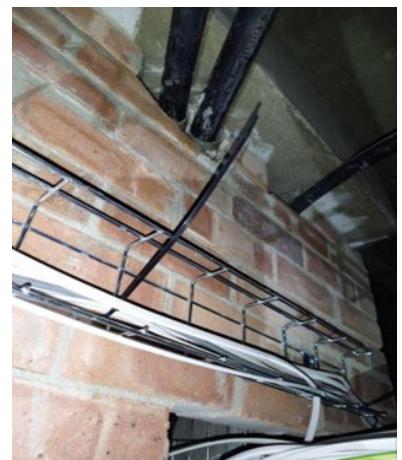
C0.13 Corridor ceiling void

Seal around armoured cabling at top of wall and soffit

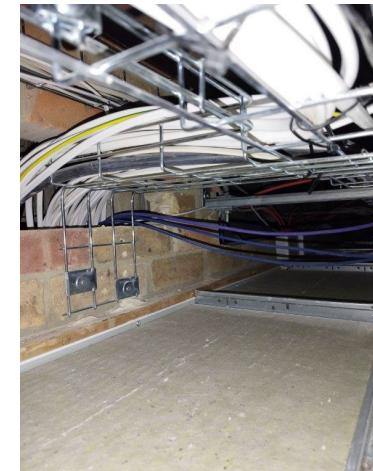
C0.13 Corridor ceiling void

6 No areas of conduit, cable trays and armoured cable breaches. Seal up all gaps in side walls

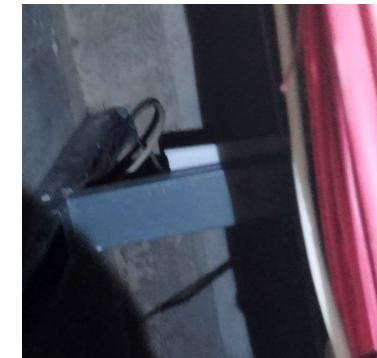
C0.2 dry riser and corridor near main entrance.

Seal conduit at high level.

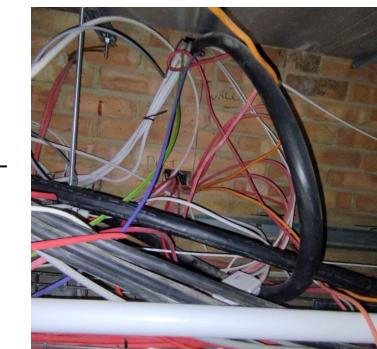
C0.2 Corridor ceiling void

Seal up where there are cables passing through opening formed in brickwork – in corridor. A number of openings found on both side walls

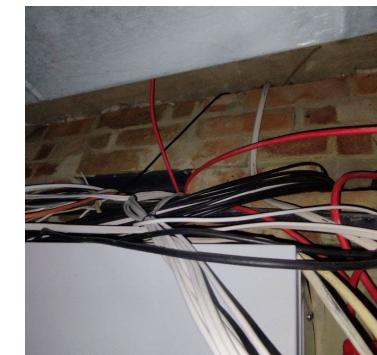
C0.2 Corridor ceiling void

Seal up where there are cables passing through top of wall and soffit

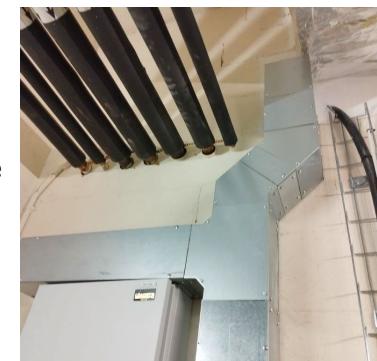
main water tank room

Seal up where copper pipes pass through wall – 2No areas - 7No pipes in one
area and 3No pipe in another area.

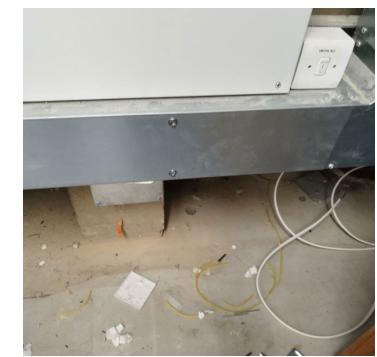
dry riser in kitchen store room
ST 1.7

Seal up small diameter hole in floor

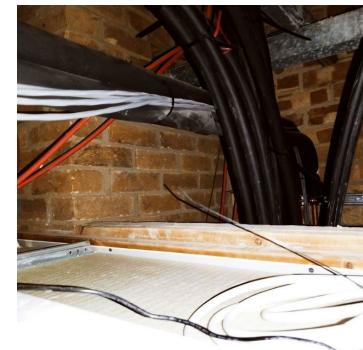
First Floor – area B dry riser in Labour Party office

Dry riser wall stops short. Leaving a void for fire transfer via the ceiling void.
Install fire blanket above face wall (panelled wall) of riser.

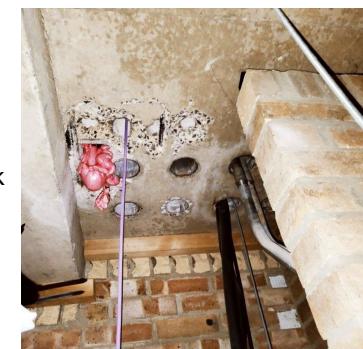
First Floor – area B dry riser in Labour Party office

Replace incorrect sealant in soffit. 8No holes passing through soffit face. Check floor to dry riser above.

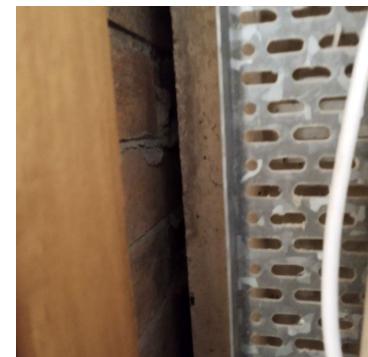
First Floor – area D C1.2 dry riser near stairs at front elevation Seal gap between columns and brickwork on both sides of door frame. To full height of dry riser

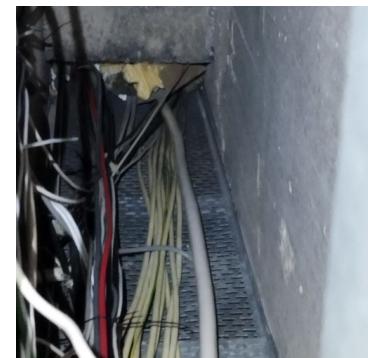
First Floor – area D C1.2 dry riser near stairs at front elevation Seal around cabling at top of wall and soffit on either side - check status of floor above.

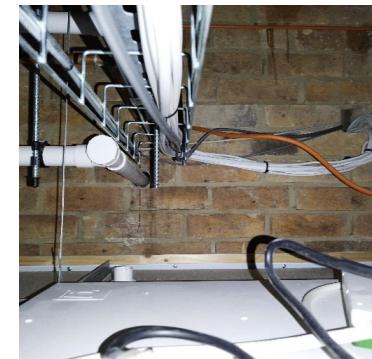
Dividing wall within compartmented area C.12

Seal around plastic waste pipe and cabling passing through wall.

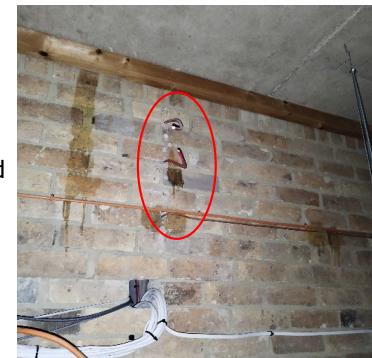
Dividing wall within compartmented area C.12

Redundant cabling and a series of vertical holes drilled through wall. Seal around plastic waste pipe and cabling passing through wall

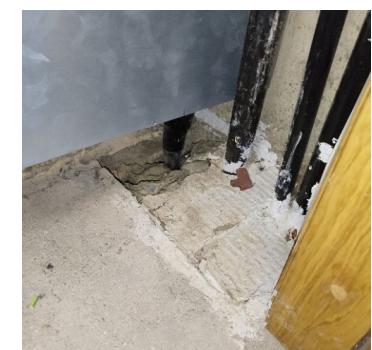
C1.9 Dry riser floor

Replace damage fire stopping on the floor, both to the right- and left-hand sides.

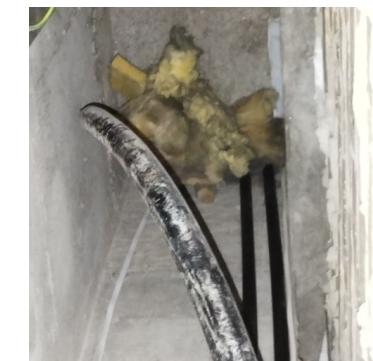
C1.9 Dry riser soffit

At soffit level, the cables passing through are sealed with fibreglass quilt. Remove and replace

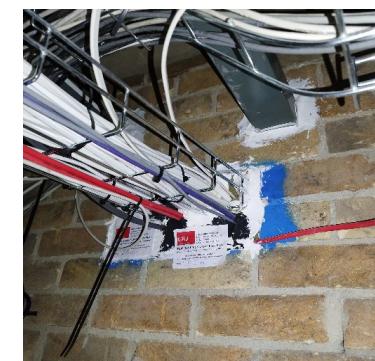
Dividing wall within compartmented area C1.7

Replace fire stopping batts where minor damage has occurred.

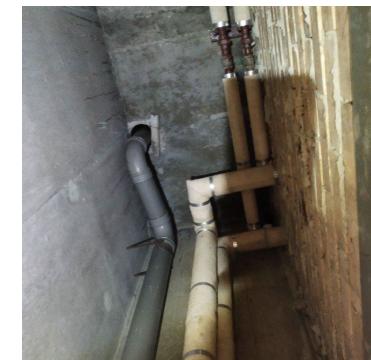
Wet and Dry Riser

Seal gap between top of column and wall at high level on left hand side

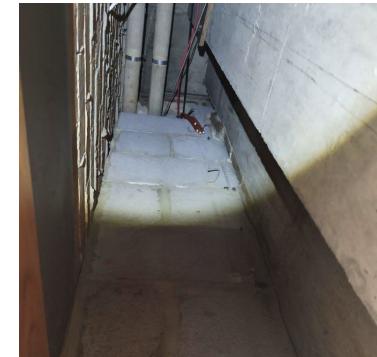
Wet and Dry Riser

Seal around cables at high level passing though missing blockwork.

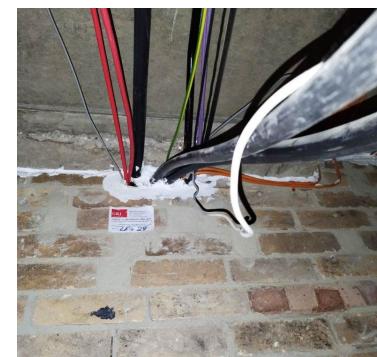
Dividing wall within
compartmented area

Repair fire stopping where damaged around 1No cable.

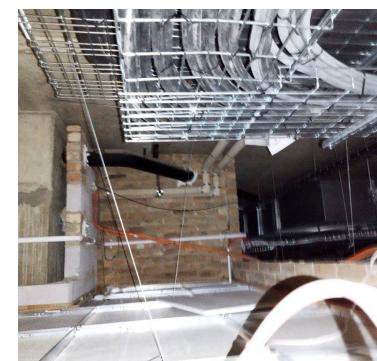
Storeroom in open plan office
area

Install fire blanket/batts
No fire stopping in ceiling void between 2No walls and
soffit. – leads into large open plan office. from soffit down to ceiling line on
2No walls.

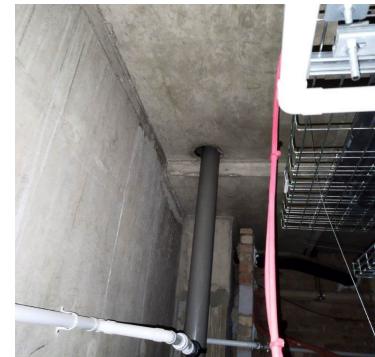
Storeroom in open plan office area

Seal around top of soil pipe passing through roof soffit.

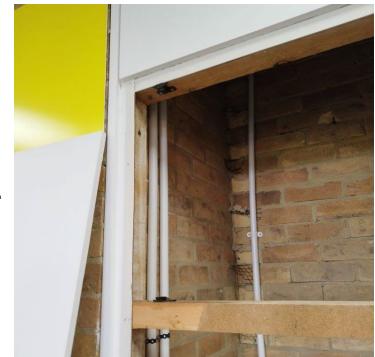
wet and dry riser in open plan office area

Face panel to riser is 18mm MDF board N softwood framework. Only secured via 2No screws and no marking on the MDF board to confirm if Fire Rated MDF. Replace with new framework and cement based board

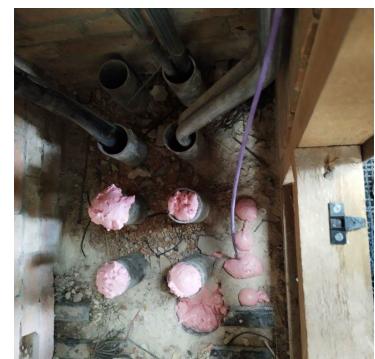
wet and dry riser in open plan office area

4No electrical cable ducts not sealed. Large diameter holes in floor fill inappropriately with foam

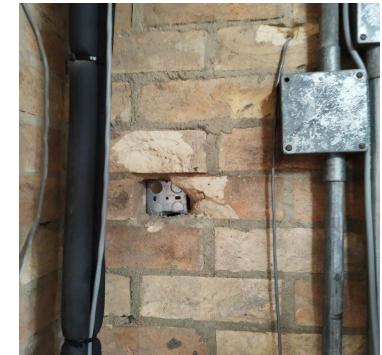
wet and dry riser in open plan office area

2No infills required to electrical back boxes.

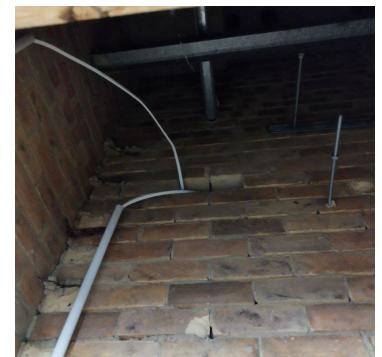
wet and dry riser in open plan office area

1N infill to missing low level brick.

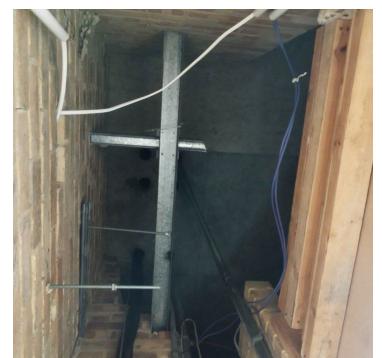
wet and dry riser in open plan office area

seal up 8No holes passing through soffit.

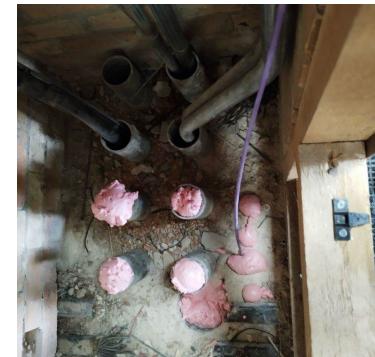
wet and dry riser in open plan
office area

Seal up 2No redundant telecommunication duct in floor. Replaced foam seal to
single cable passing through the floor.

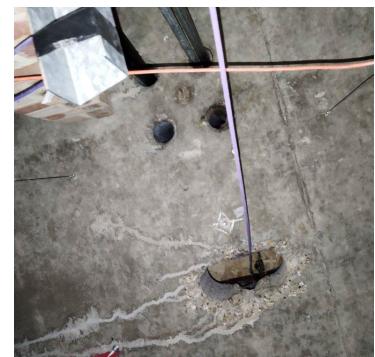
wet and dry riser in open plan
office area

Large oval shaped hole in soffit to right hand side of riser in open plan office
ceiling void.

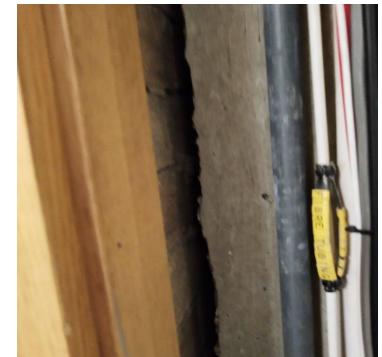
Second Floor – C2.2 area E dry riser near stairs at front elevation

Seal between columns and brickwork on both sides of door frame – full height of dry riser.

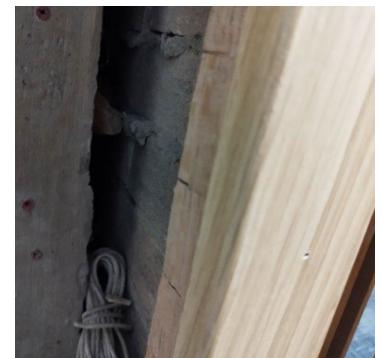
Second Floor – area E Dry Riser, rear elevation

Seal between columns and brickwork on both sides of door frame – full height of dry riser.

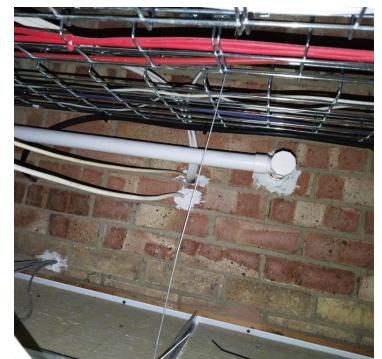
Second Floor – area E C2.4 Corridor ceiling void

Seal cable gaps passing through wall and into toilets.

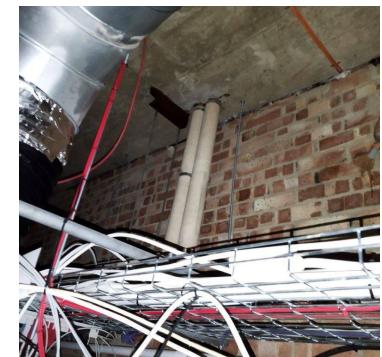
C2.4 Corridor ceiling void

Seal around 2No pipe passing through soffit in corridor ceiling, near dividing wall with toilet

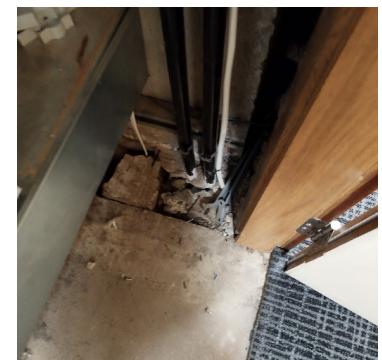
C2.6 Dry Riser facing library

Damaged fire stopping to cabling on both corner sides of floor.

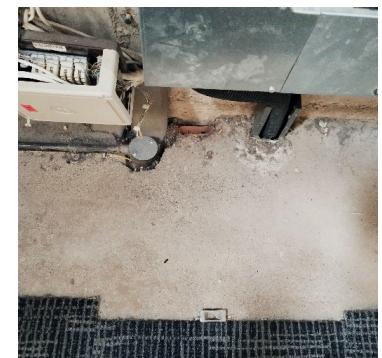
C2.6 Dry Riser facing library

Seal around 2no metal conduit, redundant conduit and junction box to floor.

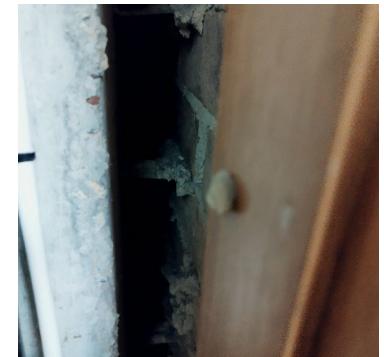
Second Floor – area F C2.6 Dry Riser facing library

Seal between columns and brickwork on both sides of door frame – full height of dry riser.

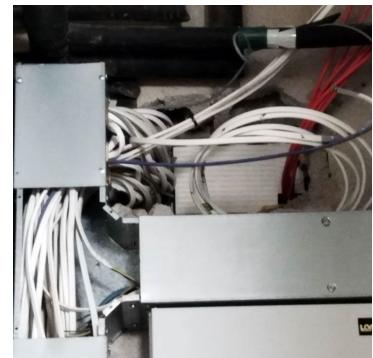
(W1)

Fire stopping is inadequate where the Pyro cables and the main power cables on the left-hand side pass through.

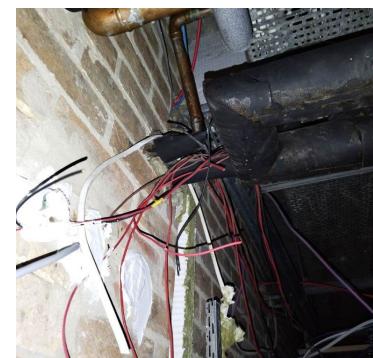
(W6)

The hole where the pipework passing through wall is only infilled with loose rockwool. Remove and insert intumescent batt and seal

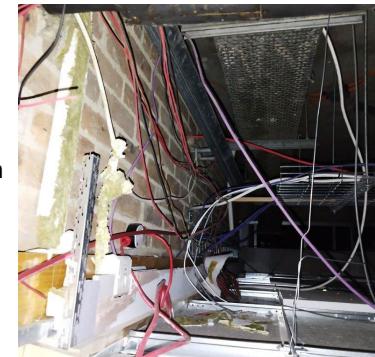
(W03)

The hole where the pipework and cable passing through wall is only infilled with loose rockwool. Remove and insert intumescent batt and seal

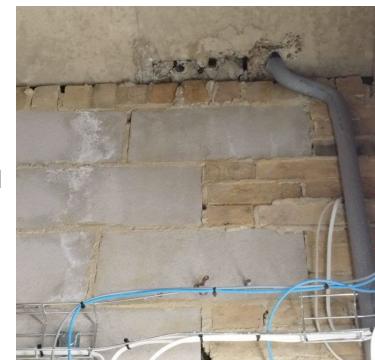
(W7)

Gaps around pipework and old/redundant pipe runs in soffit, where it is sleeved through the floor slab above.

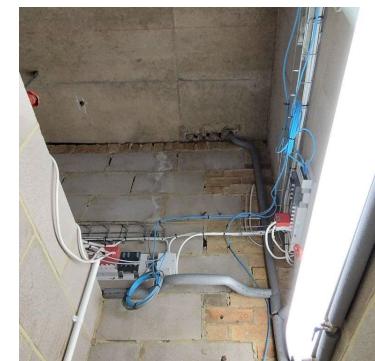
(W7)

Possible gap between the top of the brickwork and the concrete soffit. Check and make good to seal suspected gap.

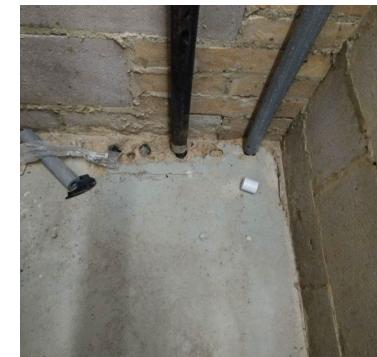
(W7)

Gaps around pipework and old/redundant pipe runs in floor slab.

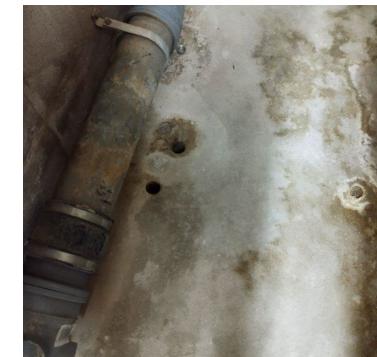
(W10)

Seal around 2No holes in floor.

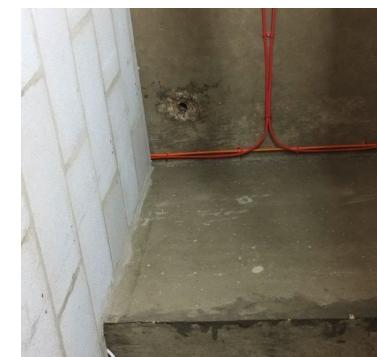
(W10)

Seal around 1No holes in soffit.

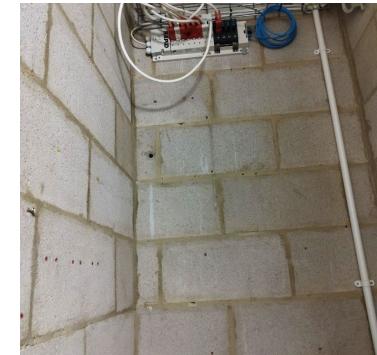
(W10)

Seal around 1No holes in blockwork

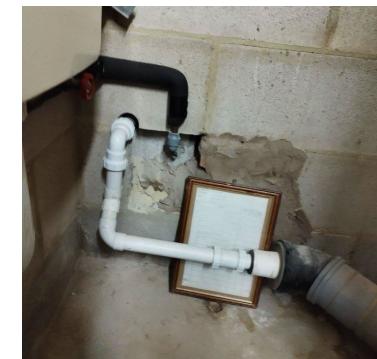
(W10)

Seal around waste pipe and copper pipe passing through fire wall.

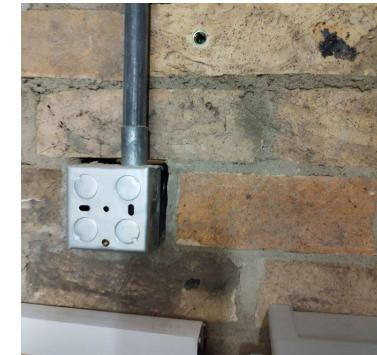
(W11)

Seal around back box.

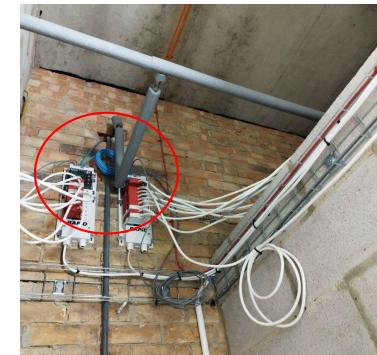
(W11)

Seal around conduit and pipe passing through fire wall.

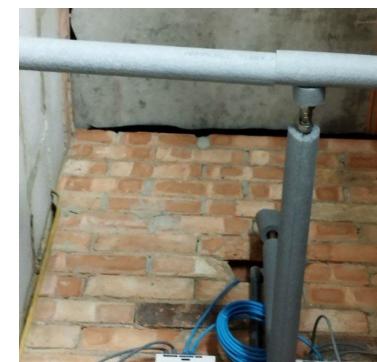
(W11)

Seal along the top of the fire wall.

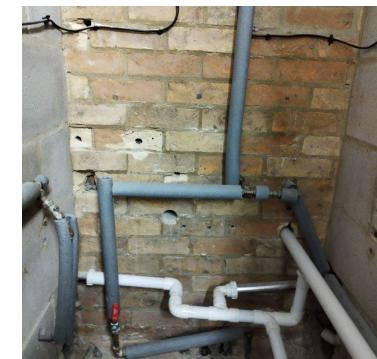
(W12)

Seal around waste pipe and numerous holes in fire wall.

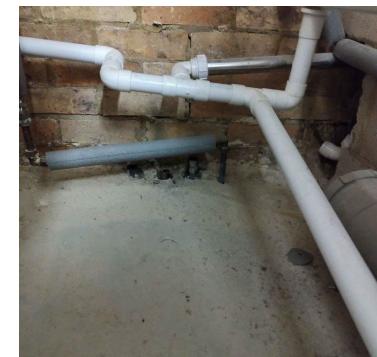
(W12)

Seal around copper pipe and 2No holes in floor.

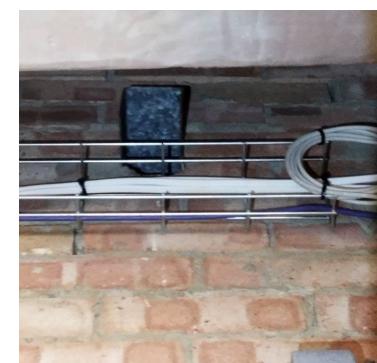
(W12)

Seal around old square conduit behind ducting.

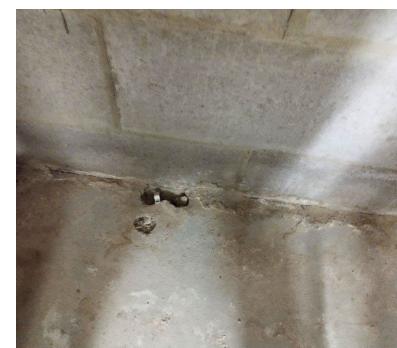
(W13)

Seal holes in floor

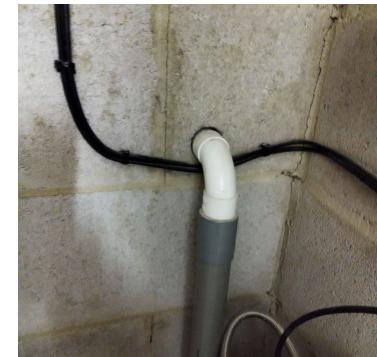
(W13)

Seal around waste pipe passing through fire break wall.

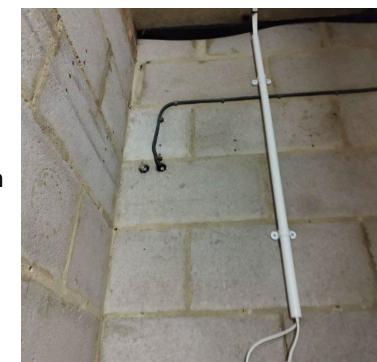
(W13)

Seal around 2No holes with "cut" cables passing through fire break wall at high level.

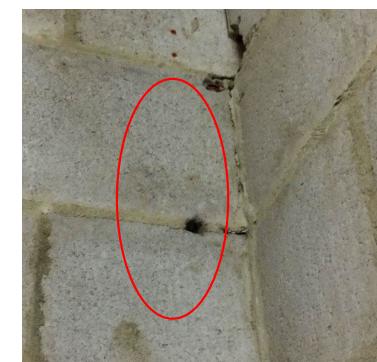
(W13)

Seal around 1No hole and "cut" copper pipe passing through fire break wall at high level.

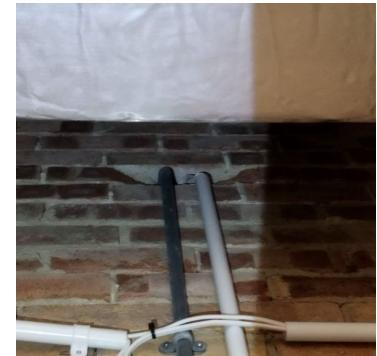
(W14)

Seal around 2No conduits and cables passing through fire break wall at high level.
