APPENDIX D

Budget Estimate

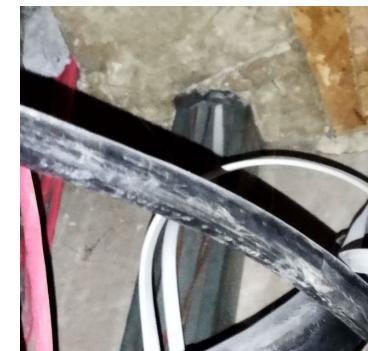
Ground floor area A

dry riser in caretakers office

Seal gap on metal conduit passing through soffit – check status of floor above.

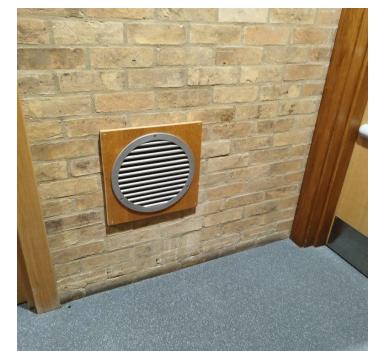
Ground Floor corridor

Corridor C0.5 outside IT store
and mail room

Remove circular vent in brick wall and seal up opening

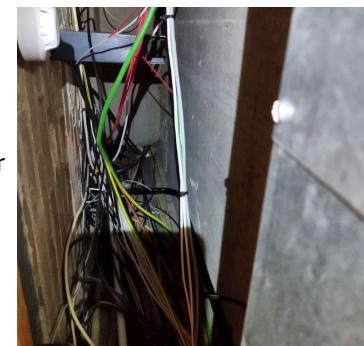
Ground floor area F

C0.2 dry riser and corridor near main entrance. Seal around cabling at top of wall and soffit at both ends - check status of floor above.

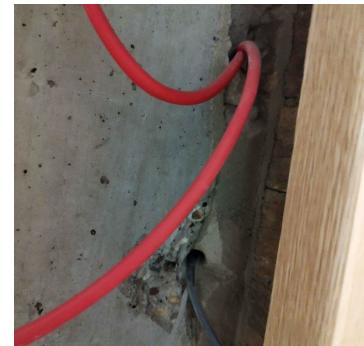
Ground floor area F

C0.2 dry riser and corridor near main entrance.

Seal around 2No cable holes to right hand side of door frame.

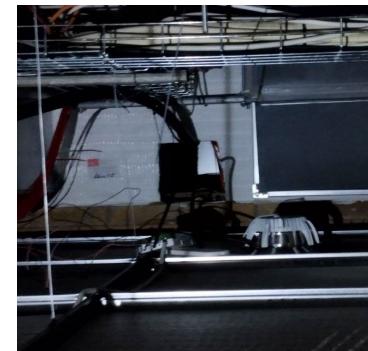
Ground floor area F

Corridor ceiling void at fire
break wall

Existing fire stopping above door frame compromised with large square hole
formed. – this is in a defined fire wall

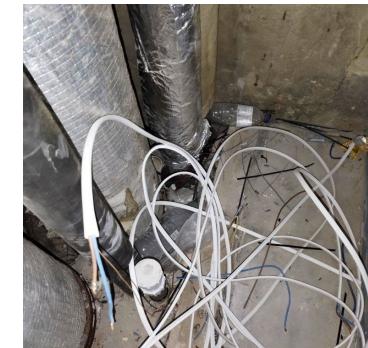
First Floor area A

dry riser in kitchen store room
ST 1.7

Seal up large diameter pipes passing through the floor to right hand side.

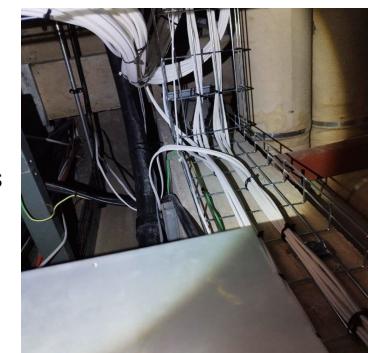
First Floor area A

dry riser in kitchen store room
ST 1.7

Seal around cables to side of left hand side column and at soffit. Check status of floor in dry riser on 2nd floor

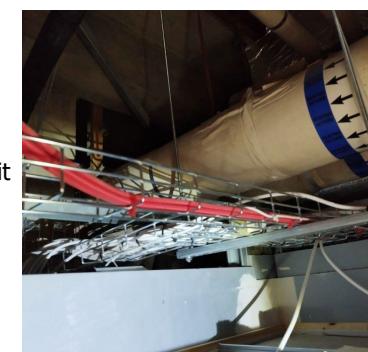
First Floor area A

dry riser in kitchen store room
ST 1.7

Dry riser wall stops short. Leaving a void for fire transfer via the ceiling void. Fit fire blanket/batts to 2No walls.

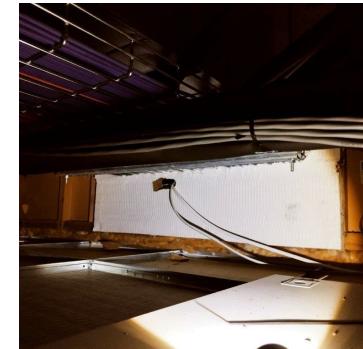
First Floor – area B dry riser in Labour Party office

Breach of fire stopping on dividing wall with adjoining office

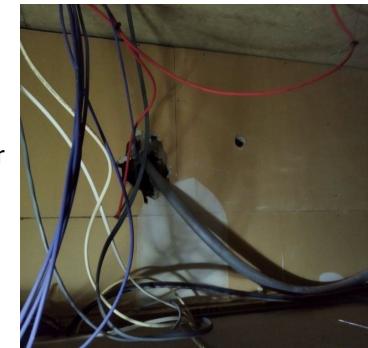
First Floor – area C AV room within Council chamber Seal around bunch of cables passing through and into the corridor. 2No further cables passing through and into the corridor. Remove timber battens between the top of the brick wall and the soffit and seal up gap – Corridor dividing wall

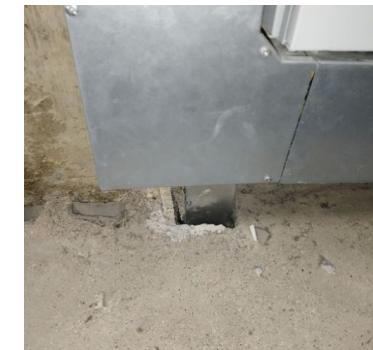
First Floor – area F dry riser facing Library

C1.9 Dry riser floor

Seal around metal square conduit. Seal around 2No redundant telecommunication ducts.

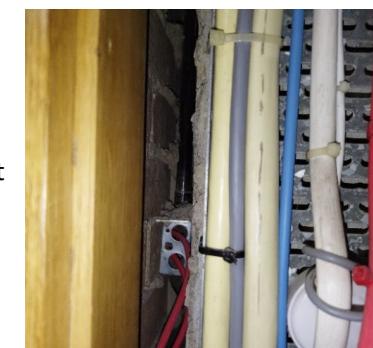
First Floor – area F dry riser facing Library

C1.9 Dry riser

Seal between columns and brickwork on both sides of door frame – full height of dry riser.

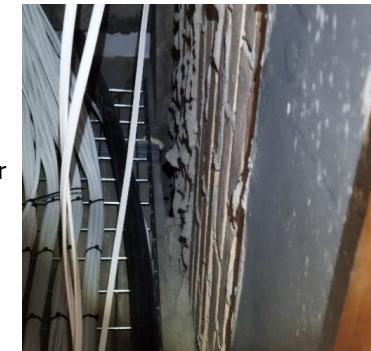
First Floor – area G

C1.7 dry riser facing rear.

Seal up gaps between the brick face wall and the concrete column, above door frame and to underside of concrete soffit beam.

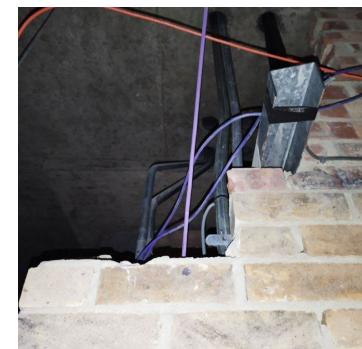
wet and dry riser in open plan
office area

Install fire blanket from soffit down to ceiling line on 3No walls.
